Case Study Klaus Kada's Festspielhaus, St. Polten

Building:	Klaus Kada's Festspielhaus
City:	St. Polten
Country:	North Austria
Products:	Dow Corning® 993
Architect:	Klaus Kada
Curtainwall:	Officine Lorenzon SNC

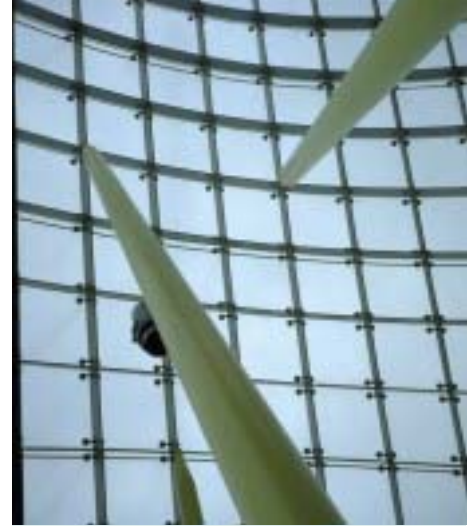
Dow Corning's structural silicone sealants were again used in developing a new glass bonding system for the roof of the building and the entrance facade, helping Kada to realise his vision. The insulating glass used in both areas was 'semi-drilled'. For the internal panes, the standard bolting system was used, with the bolts being fixed through the glass; for the external glass, however, the bonding was achieved using Dow Corning® 993 silicone sealant, with no drilling taking place.

This 'semi-drilled' system for bonding glass, takes advantage of the benefits of a bolted system, but provides the architect with a totally smooth glass facade. The absence of drilling on the external glass enhances the thermal properties and longevity of the insulated glazing unit and also significantly reduces the manufacturing costs. This system has been more widely used than the 'no-drilling' technique used for Hans Hollein's Ausstellungshalle, but awareness of the benefits it brings is still low among many architects.

- Dow Corning's structural silicone sealants were used in developing a new glass bonding system for the roof of the building and the entrance facade. The insulating glass used in both areas was 'semi-drilled'. For the internal panes, the standard bolting system was used, with the bolts being fixed through the glass; for the external glass, however, the bonding was achieved using Dow Corning 993 silicone sealant, with no drilling taking place.
