## P R O J E C T

*Long-lasting, preformed silicone seal from Dow Corning was used to stop leaks in the barrel vault skylights at the Denver Performing Arts Complex in Denver, Colorado.*

## Silicones stop leaks at block-long barrel vault skylight system

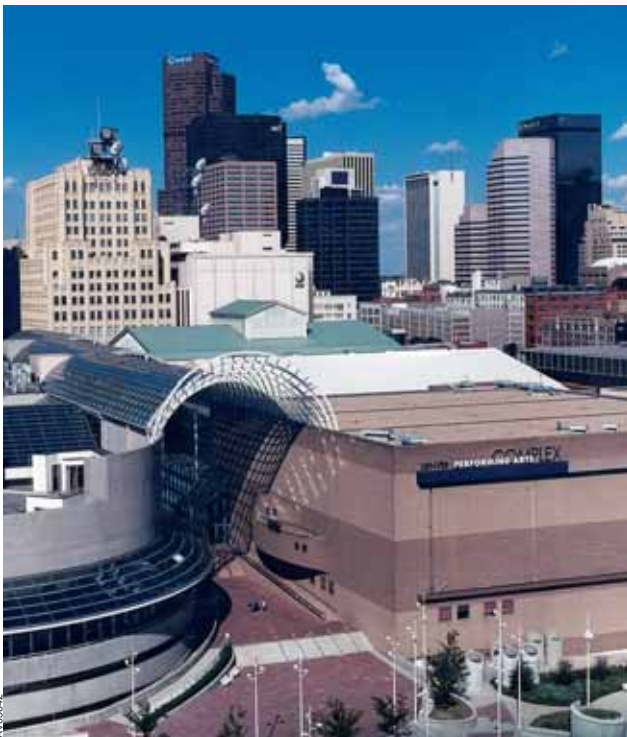
*The Denver Performing Arts Complex in Denver, Colorado, is a block-long complex of theaters, concert halls and other performance spaces protected from the elements by three 80-foot-high glass archways.*

The two barrel vault skylights at the Denver Performing Arts Complex earmarked for renovation are made up of 1,100 panes of glass, most of them measuring three-and-a-half feet by eight-and-a-half feet, in an aluminum framing system. Where the framing components intersect – typically a problem area in leaking skylights – extrusions of *Dow Corning* 123 Silicone Seal were cut to span the joint intersections.

According to Dick Butler, president of J.R. Butler, the renovation work on the two skylights was extensive. “We re-torqued 30,000 screws in the framing and installed completely new expansion joints in each vault and in between. We had to clean years of dirt and grime off 1,100 pieces of glass and the aluminum framing before we could apply any sealants or the 123 Silicone Seal to address the leaking joints.”
