Dow Corning® 123 Silicone Seal stops leaks at Pittsburgh's premier condominiums.

Trimont Condominiums, Pittsburgh, Pennsylvania, USA

Dow Corning® 123 Silicone Seal stops recurring water leaks at the premier condominium complex in Pittsburgh, Pennsylvania.

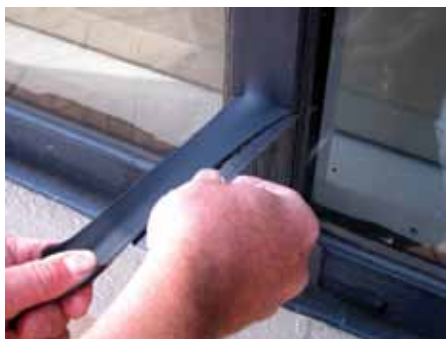
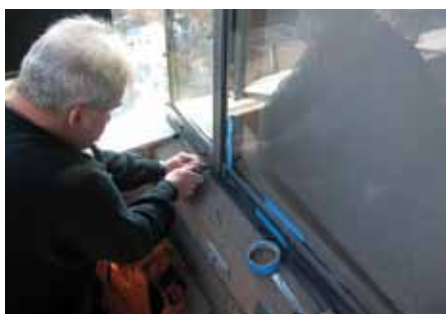
Photos, top to bottom: Page 1 – AV15635; Page 2 – AV15633, AV15634.

Using the same procedure developed for the mockups, Airtite cut an angle into the glazing gasket around the windows and applied a cap bead of *Dow Corning* 795 Silicone Building Sealant. They then sealed the metal-to-metal connections between the windows (both vertical and horizontal), as well as the exterior sill where the metal sill hits the concrete, with *Dow Corning* 123 Silicone Seal and *Dow Corning* 795 Silicone Building Sealant.
